(2008) - Sixth International Conference on Case
Histories in Geotechnical Engineering

Some Lessons from Yogyakarta Earthquake of May 27, 2006

SOME LESSONS FROM YOGYAKARTA EARTHQUAKE OF MAY 27, 2006

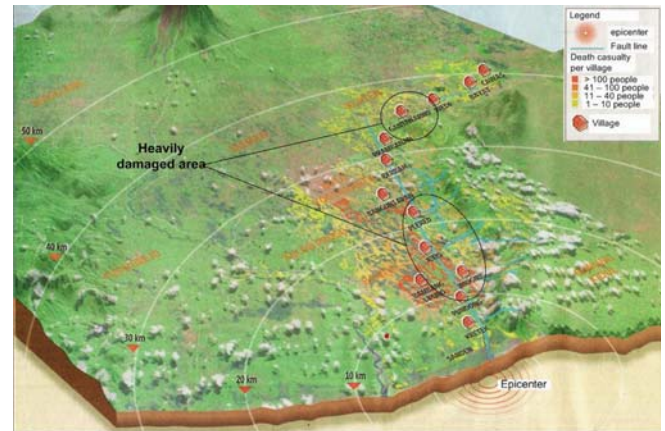
Fig.1.Reported Opak fault and damage to nearby villages (Kompas 2006)

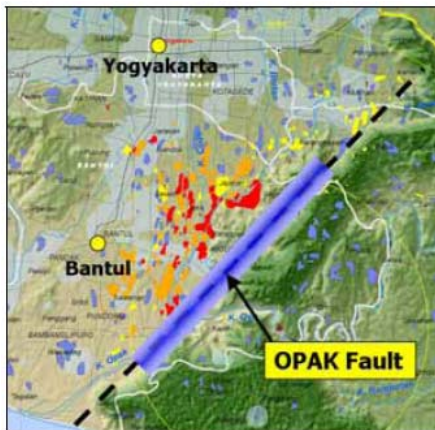
About 50 km from center of Yogyakarta to southern part, it has been found two main faults. The first fault extends to north-east while the second fault stretches to south-west (Rahardjo *et al.* 1977). The first fault expands along the Opak River which is called as Opak fault. The length of fault is about 36 km with zone width is estimated from 200 to 500 m. These faults is not classified as the active fault, however it can be triggered by huge earthquake such as Yogyakarta earthquake occurred on 27 May 2006. Some studies conducted by Sudarno (1997) indicate that the main fault has located under ground along the Opak River. This fault formation was predicted occurs in the Oligo-Miosen tectonics phase (about 25 millions years ago) while south west fault occurred in Pliosen phase was calculated about 1.5 millions years ago (Pramumijoyo *et al.* 2004). This phenomenon caused the uplift of south areas of Wonosari to the height of 200 m from sea water level. From Fig.3, the Opak fault and its damage to nearby areas are presented. The estimated epicenter by NIED (Nakano *et al.* 2006) is located near Opak fault. The epicenter and presumed fault region is well correlated with damage levels in the affected area provided by UNOSAT as shown in Fig.3.

Fig. 3. Opak fault and its near damage areas (<http://www.unosat.org>)

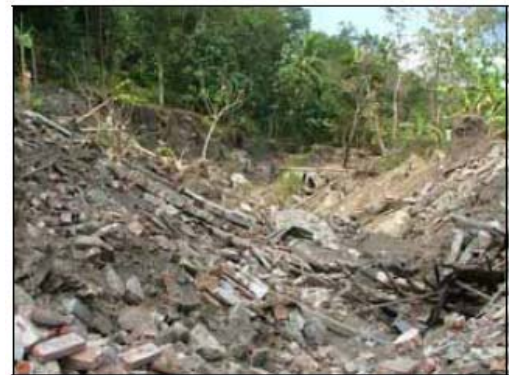
Fig.4. Ground slumping at Nglepen - Sengir (Sumberharjo), north of Opak fault (Photograph by Elnashai *et al.* 2006)

In several areas building foundations were severely affected by ground deformation caused by the landslide reported by Elnashai *et al.* (2006). Figure 4 shows a combination of ground slumping and landslide on the hillside at north of the Opak fault. Housing units built on the hillside were heavily damaged or totally collapsed due to ground failure. Figure 5 shows large ground cracks running through the village. In some pavement roads closed to earthquake epicenter was heaved and damaged, as shown in Fig. 6, along a path in

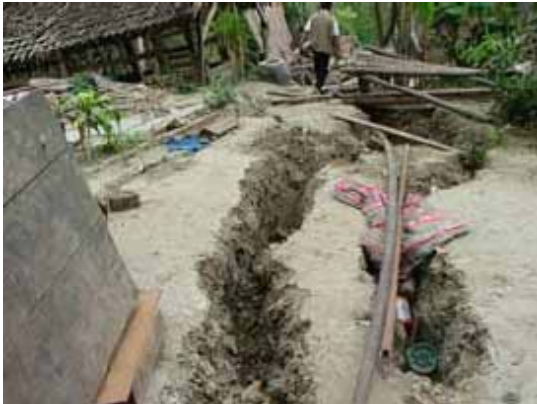
*Fig.5. Ground cracks near residential area
(Photograph by Elnashai et al. 2006)*

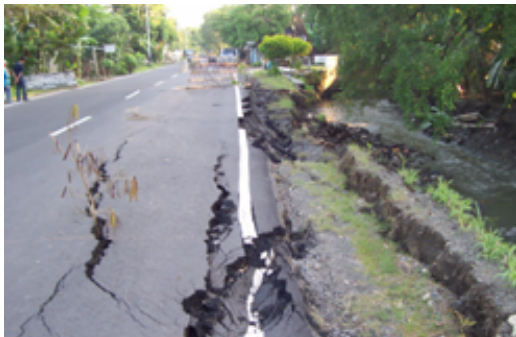
Bantul. Those cracks are parallel with distance 5 to 10 m apart, and the crack widths are about 4 to 15 cm.

Fig.6. Ground cracking and settlement due to permanent deformation along a road shoulder

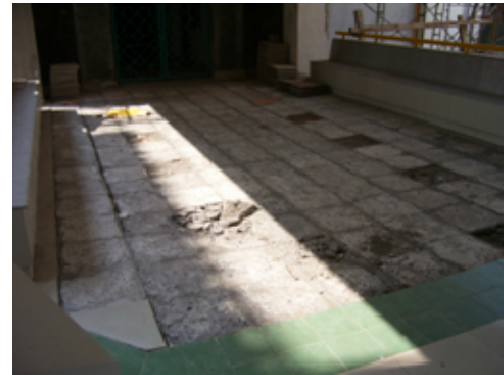
around the Muhammadiyah University of Yogyakarta (UMY) campus buildings were observed as shown in Fig. 7 and 8. Furthermore, several signs of soil liquefaction were observed nearby (Fig.9).

Fig.7 Inclined campus floor due to liquefaction

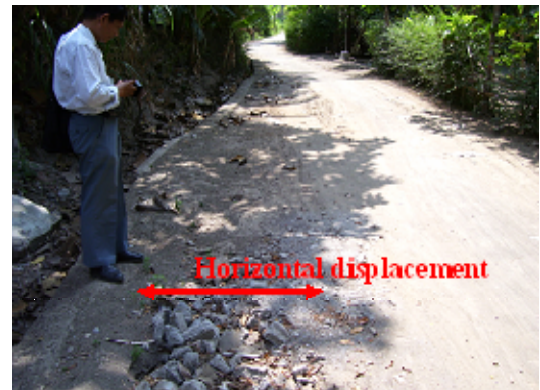
Fig. 8. Horizontal displacement found in Gamping near UMY campus

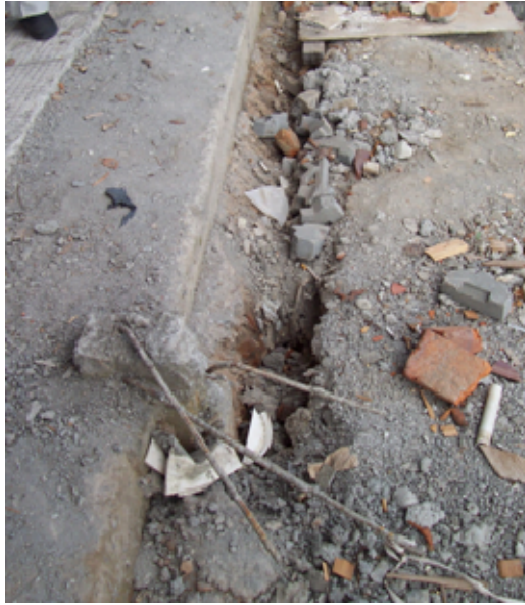
Fig.9. Liquefaction-induced lateral spreading near the UMY campus buildings

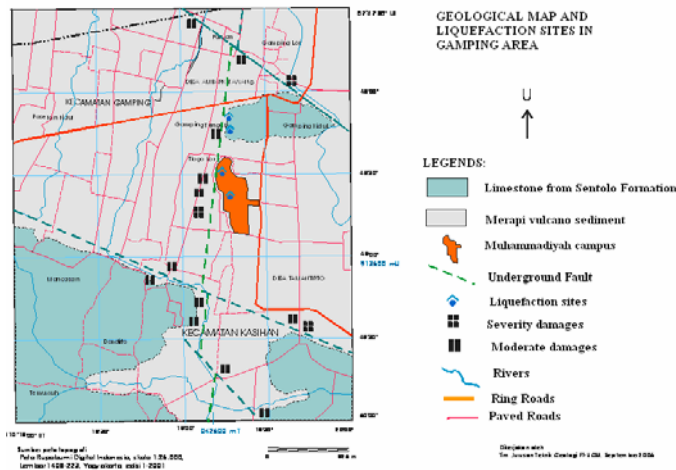
Fig.10. Location of observed liquefaction and underground fault line

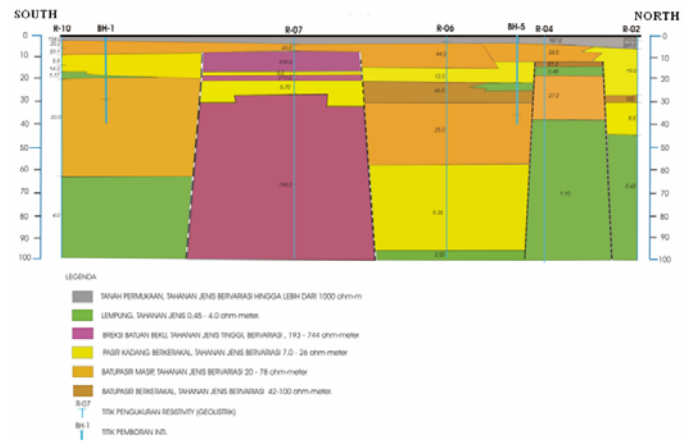
Therefore, contour maps of resistivity were developed for assisting the subsurface interpretation for the depth of 10, 20, 30, 40, 50 and 80 m. The map represents the lateral distribution of rock resistivity in related depths. Figure 13 shows some examples of contour map used in this study. The final result of observation is presented in Fig.14. The underground fault is clearly detected under liquefaction sites. During earthquake shaking, the water pressure to increase to the point where the soil particles can move with respect to each other. It was also found that the loose to dense sand layer is in depth from 60 to 90 meter over clay layer.

Fig.14 Geological section from geo-electric survey and result from the bore-log observations

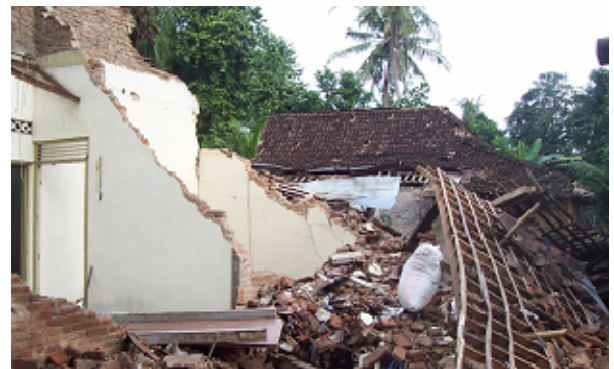
Fig.15. Collapsed housing

The main causes of damage to this type of housing are discontinuity of load path and brittle characteristics of materials. Due to poor anchoring of roof-to-wall and wall-to-foundation, there are no continuous load paths to transfer the inertia force from the building to the foundation. In many

cases, sliding of the timber roof off the masonry wall was observed. Since clay bricks are produced in large numbers and at a low cost without any standard, its quality is much dependent on the local conditions and circumstances. The most salient damage features of non-engineered buildings were:

1. Failures at corners of walls and at doors and window openings
2. Roof system sliding off the supporting walls
3. Shear, flexural or combined cracking of masonry brick walls
4. Failures at connection regions between roof, wall and foundations

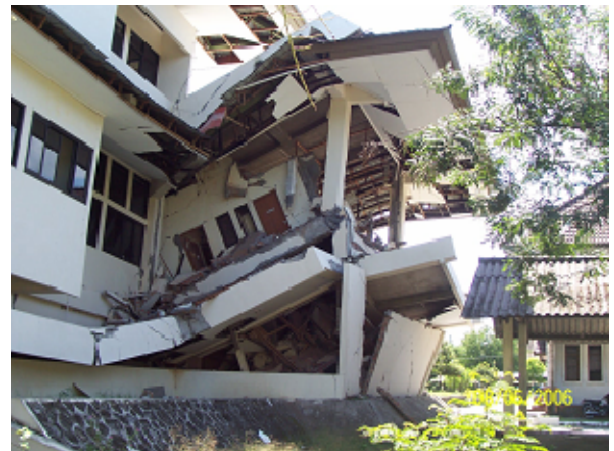
Fig.16. Collapsed reinforced concrete structures of BPKP building

Many of these buildings collapsed or were seriously damaged. Structural damage can be attributed to non-ductile detailing, insufficient confinement reinforcement in columns, lack of lateral resisting system, and poor quality construction. Short-column effect and soft-story actions contributed to the damage in some of the buildings. Nonstructural damage in the infill walls was observed in various low-rise buildings, especially at the lower floors. The BPKP (Badan Pengawasan Keuangan dan Pembangunan) governmental building collapsed due to poor detailing and insufficient confinement reinforcement (Fig.16).
